56th and Walnut—A Philly Gut Rehab Development

S. Puttagunta, O. Faakye, W. Zoeller
Consortium for Advanced Residential Buildings

July 2013

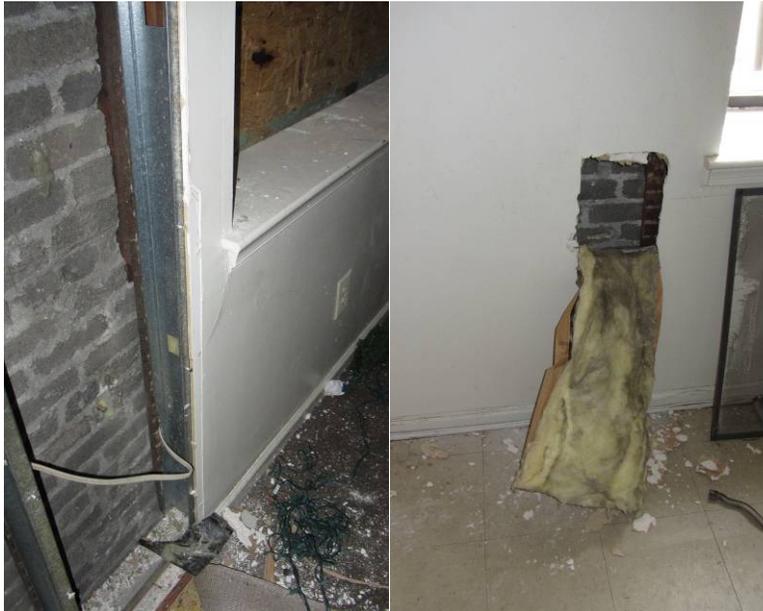
The exterior wall assembly of these apartments comprises multiwythe solid brick-masonry with vertical wood furring between 2 × 4 steel studs at 16 in. on center (o.c.) and the masonry wall (see Figure 3). The steel-stud wall cavities are filled with R-13 Kraft-faced fiberglass insulation. The poor installation (Grade III), conductive nature of the steel studs, and signs of air movement in the wall cavity, as evidenced by the dirt on the backside of the fiberglass insulation, result in a derating of the fiberglass insulation to the equivalent of R-4 cavity insulation.

Figure 3. (L) View of wall assembly construction; (R) spot checks of the batt insulation showed poor installation and air movement within the wall cavity

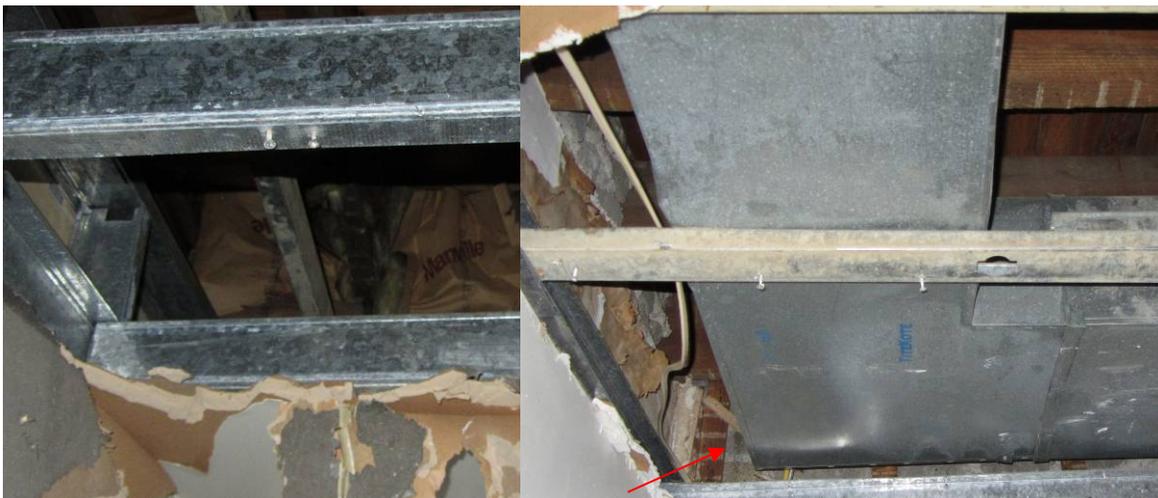
It was also found that the rim/band joist areas were poorly insulated. In some cases, where ductwork ran near the exterior wall, no insulation was found due to the duct obstruction (Figure 4).

Figure 4. (L) Poor installation of batt insulation at the rim/band joists; (R) missing rim/band insulation due to ductwork obstruction

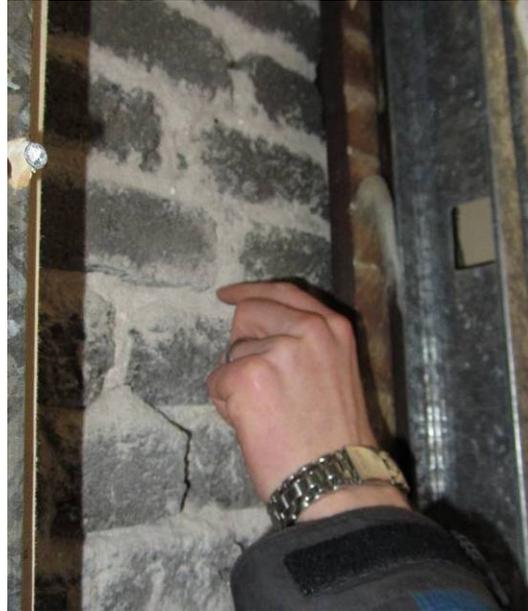
Once the interior walls were gutted, it was observed in a couple small areas that the brick mortar was deteriorating (Figure 5). Cracks in the brick wall were found above these areas. This deterioration was likely a result of a bulk moisture migration breaking down the high lime content mortar of the masonry wall. There were additional signs of moisture issues on several of the window sills, as evidenced in Figure 6, with paint bubbling and the wood sill being soft to the touch.

Figure 5. Brick mortar crumbling just from the touch of a finger

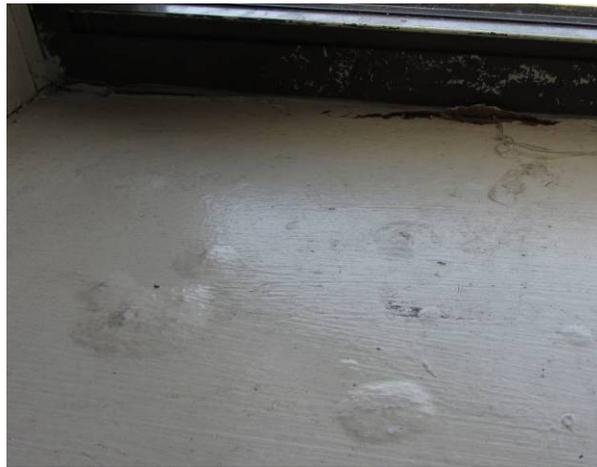
Figure 6. Bubbling of paint on window sill

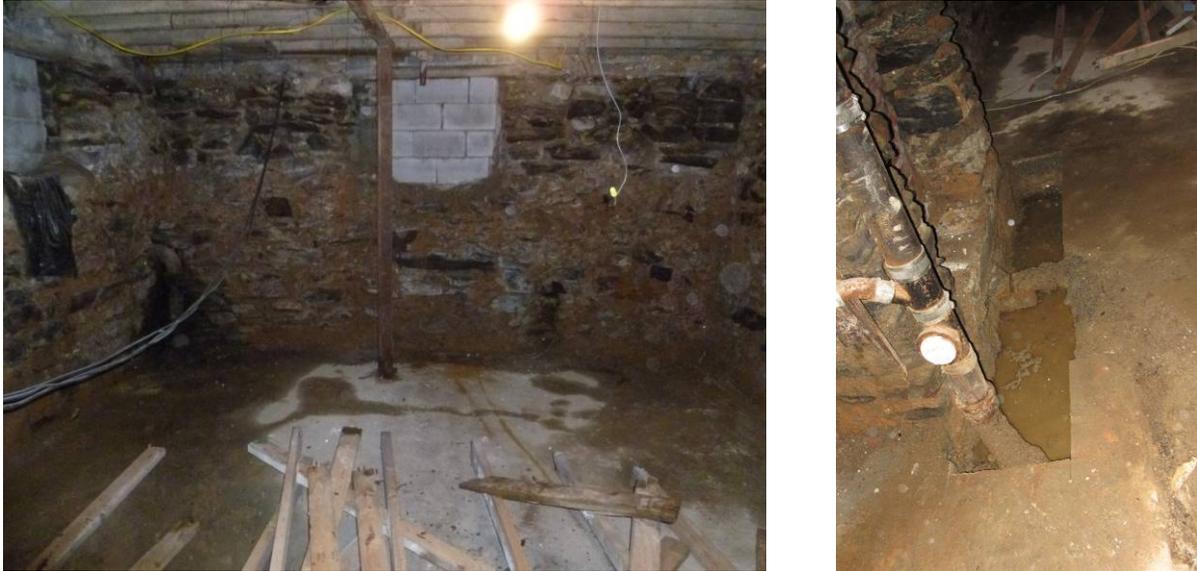
The apartment buildings have uninsulated rubble stone foundations. During the initial inspection, water was observed on the rubble stone as well as the concrete slab. Rarely do these buildings have proper water- and damp-proofing on the exterior of the foundation walls or a capillary break and vapor retarder under the foundation slab. In this portion of Philadelphia, the water table is roughly 12–18 in. below the slab, so moisture continually wicks up into the basement.

Figure 7. (L) The existing foundation has moisture issues with water intruding through the foundation walls and slab. (R) When additional footing supports were being dug, it was clear that the water table is quite high in this area.

Resolving this moisture issue is complicated in existing structures without ripping up the existing slab. CARB offered various alternatives to address this common and significant barrier. These foundation solutions are not cost effective, as they go beyond just energy consumption and address durability, indoor air quality, and comfort issues. The benefits cannot be objectively quantified solely in terms of monetary savings, especially in these apartments, as the basement is common space and not part of any specific apartment.

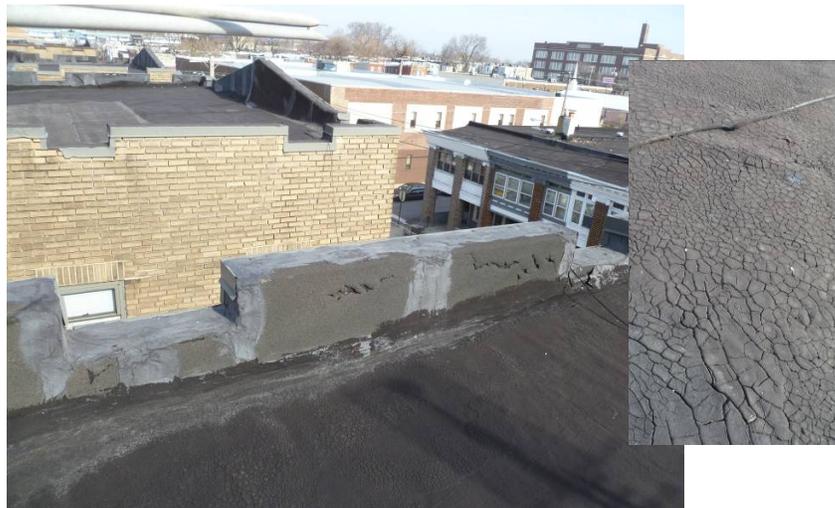
The flat roofs of these buildings were in need of repair to control bulk water, as the asphalt hot-mop roof was deteriorating (Figure 8). Insulation of the roof assembly was R-30 batt insulation installed at the ceiling plane in the unvented cockloft attic space.

Figure 8. Deterioration of roof as evidenced by “alligatored” asphalt coating and degraded coating on parapet

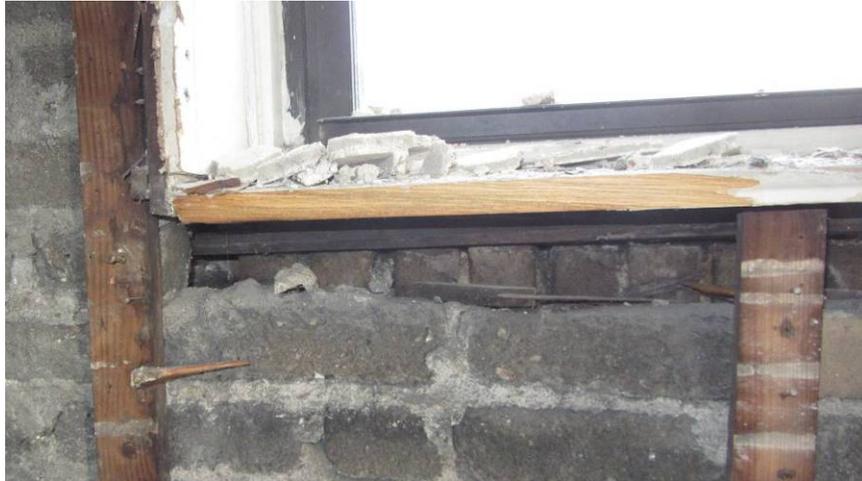
Dual-pane steel-frame windows were installed during the 1990s renovations, but there was no focus on air sealing or insulating the rough window openings. In many instances, the inner brick course under the window sill was knocked out (Figure 9). In addition, in several locations the steel angle headers over windows deflected, allowing additional pathways for air, moisture, and water to enter the wall assemblies.

Figure 9. The inner course of brick was removed when installing the windows back in the 1990s renovation

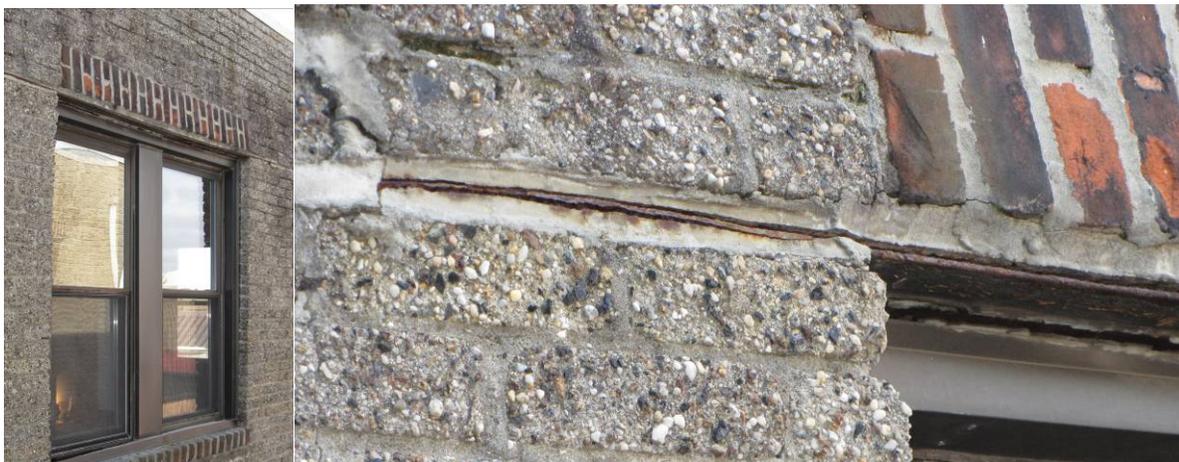
Figure 10. Deflection of steel angle window header

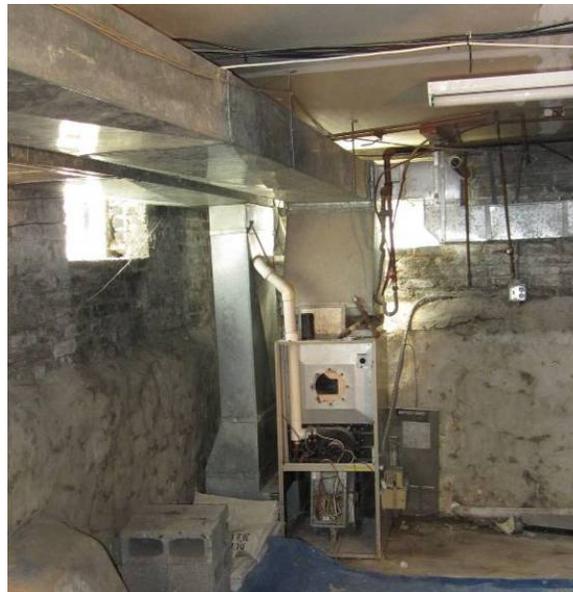
The furnace units had a heating capacity of 45 kBtu/h with a burner efficiency of 90% AFUE. On the cooling side, 2-ton A/Cs with a SEER 10 rating were supplying each apartment. The cooling equipment was in poor condition. The condenser fins on many of these units were dented or damaged, debris was observed on the indoor evaporator coils resulting in restrictions to heat transfer and airflow, and the A/C units hadn't been serviced in years, so the refrigerant charge was likely low. Actual performance was estimated to be SEER 8 or less. Ductwork runs in the basement for the first-floor apartments (Figure 12), between floors for the second-floor apartments, and in the unvented attic space for the third-floor apartments. The existing sheet metal ductwork was uninsulated, in poor condition, and showed no signs of duct sealing.

Figure 12. Uninsulated and leaky HVAC system for a first-floor apartment located in an unconditioned basement

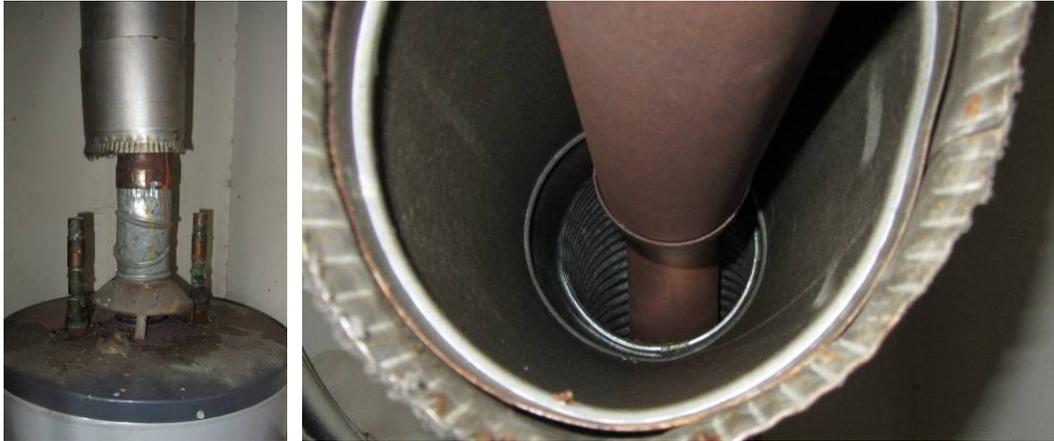
Hot water for each apartment was provided by an atmospheric gas storage tank water heater with an EF of 0.57. In two apartments, the water heater had been replaced more recently with a power/direct venting system (0.63 EF). To provide make-up air for the atmospheric water heaters, the installing contractor made a concentric flue, as shown in Figure 13. This is not a recommended practice.

Figure 13. Make-up combustion air being provided for the water heater

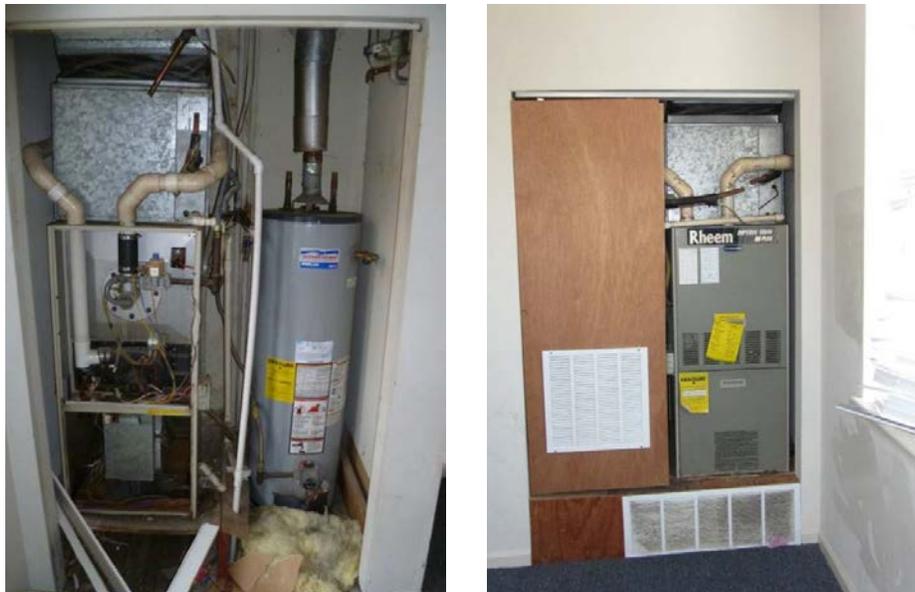
Of greater concern is the location of the atmospheric water heater, as it is located in a bedroom mechanical closet with the furnace. The issue is that the furnace utilized a central return. This central return was a platform box under the furnace with a grille facing the closet door. The closet door also had a transfer grille cut into it to draw air from the main living space. With the high amount of air leakage around the return plenum platform, there is the potential for the return to cause the mechanical closet to be depressurized and lead to back-drafting of the water heater (spilling flue gases, including carbon monoxide (CO) back into the living space).

Figure 14. Atmospheric water heater located in furnace air handler closet with poorly sealed central return

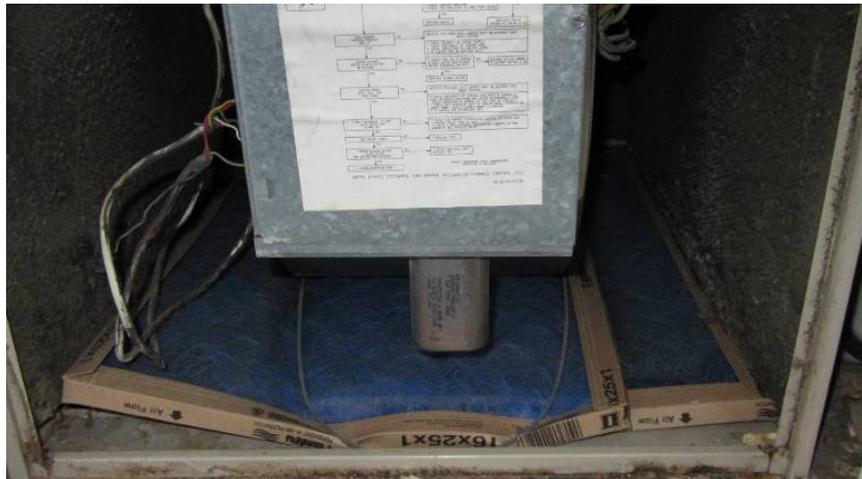
An additional health concern was the improper filtration of the existing furnaces. In several instances, improper filters were installed in the furnaces as the filter size was not a standard option. The filters shown in Figure 15 are both the wrong size for this furnace cabinet and improper media filter material to provide appropriate particulate removal capacity. Filters are classified by a minimum efficiency reporting value (MERV). Fiberglass panel filters tend to have MERV ratings of 4 or less and will tend to have a dust spot efficiency of less than 20%. At a minimum, a 1-in. pleated air filter is recommended to remove more particulates (3–10 pm particle size) from the air stream, but this type of filter needs to be accounted for in the HVAC design to not adversely affect system airflow. A 1-in. pleated air filter will typically have a MERV between 5–8 and have a dust spot efficiency between 20%–75%.²

Figure 15. Improper air filters installed into existing furnaces

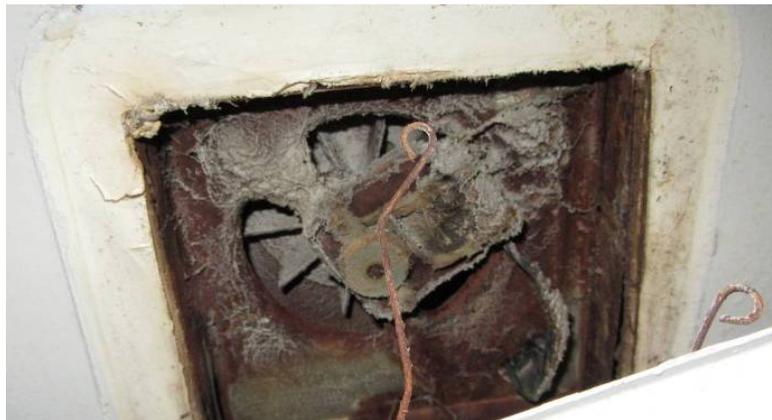
These apartments did not have any whole-house ventilation installed. Still, the local exhaust ventilation in the kitchens and bathrooms was poor or nonexistent. Bathroom fans were quite old and haven't been maintained at all, as shown in Figure 16. Kitchen range hoods were not ducted to the exterior.

Figure 16. Condition of existing bathroom exhaust fan

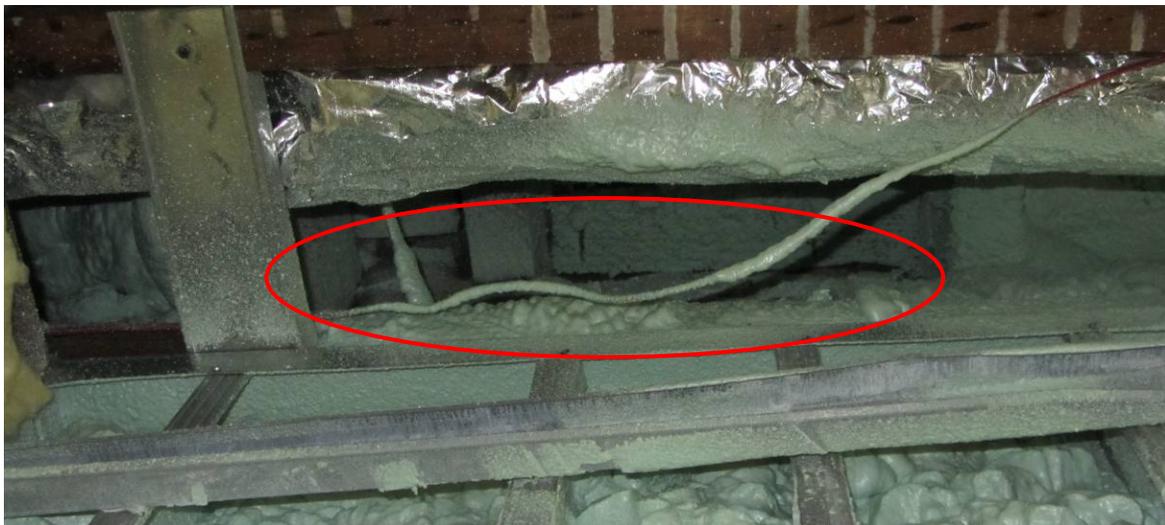
ccSPF insulation applied to the roof deck roof was difficult in some instances due to the sequencing of the contractors. The ductwork rough-in was done prior to the roof underside insulation. In certain locations, ducts were hung close to the underside of the roof deck, making applying the ccSPF difficult (Figure 25). In addition, the complex framing typical of low-sloped cockloft-type roof cavities in older buildings was challenging. The arrangement of roof rafters, ceiling joists, and vertical compression struts connecting the two form voids and narrow gaps that are difficult to access and fill (Figure 26). CARB recommended that the schedule be adjusted in the future to allow for the insulator to come out prior to installation of the mechanical duct rough-in, so the roof deck can be insulated without any obstructions. This would allow a better line of sight and physical access for the spray gun to apply insulation.

Figure 25. Minimal ccSPF insulation against the roof deck due to obstructive ductwork

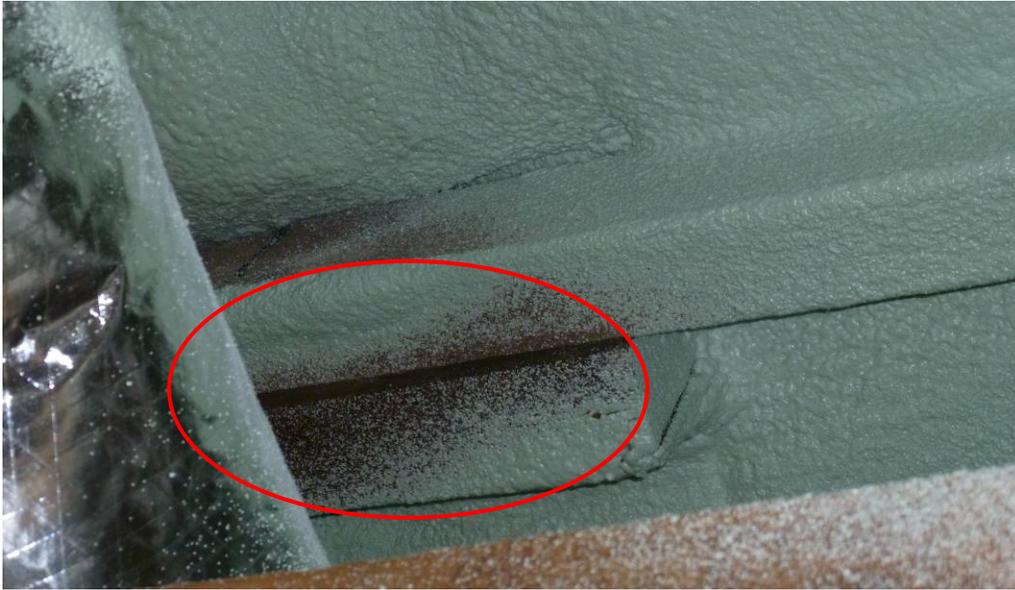
Figure 26. ccSPF should be applied to the whole length of these “sister” trusses to seal gap

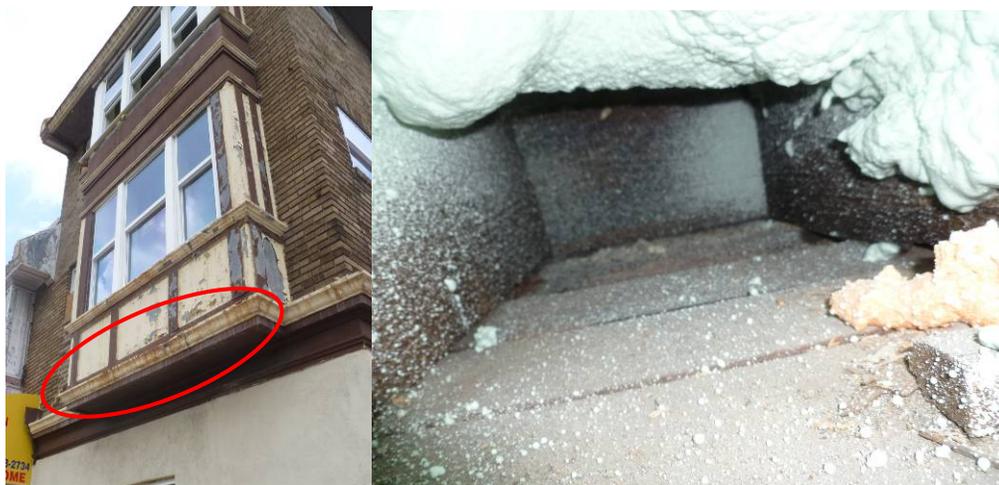
One of the buildings has a window bay projection (Figure 27). The overhang at the exterior window bay bump-out was insulated at the subfloor with ccSPF insulation, but no air/thermal block was installed in the floor joists where the overhang meets the exterior wall. Therefore, cold air could leak into this overhang and travel through the floor joists between the conditioned apartments. CARB recommended using rigid extruded polystyrene insulation to provide a thermal barrier. The corners of the rigid insulation were sealed with spray foam to provide a continuous air barrier.

Figure 27. (L) Location of thermal/air bypass in exterior wall bump-out; (R) Looking from the interior ceiling out into the floor overhang of the window bay

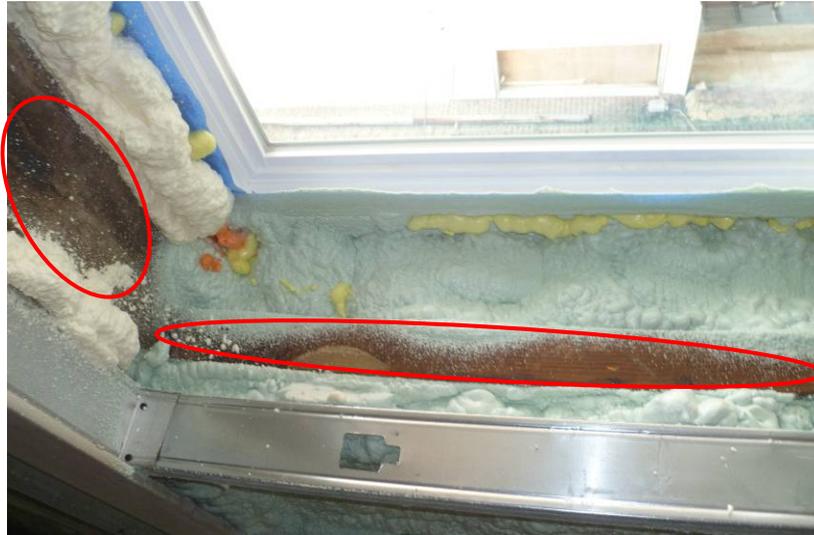
Several of the window sills were not well insulated. As shown in Figure 28, there were uninsulated brick surfaces and wood bucks at the window rough openings. CARB recommended

Figure 28. Missing ccSPF insulation around window rough opening

that the ccSPF extend the full depth of the window rough opening or rigid extruded polystyrene insulation be installed.

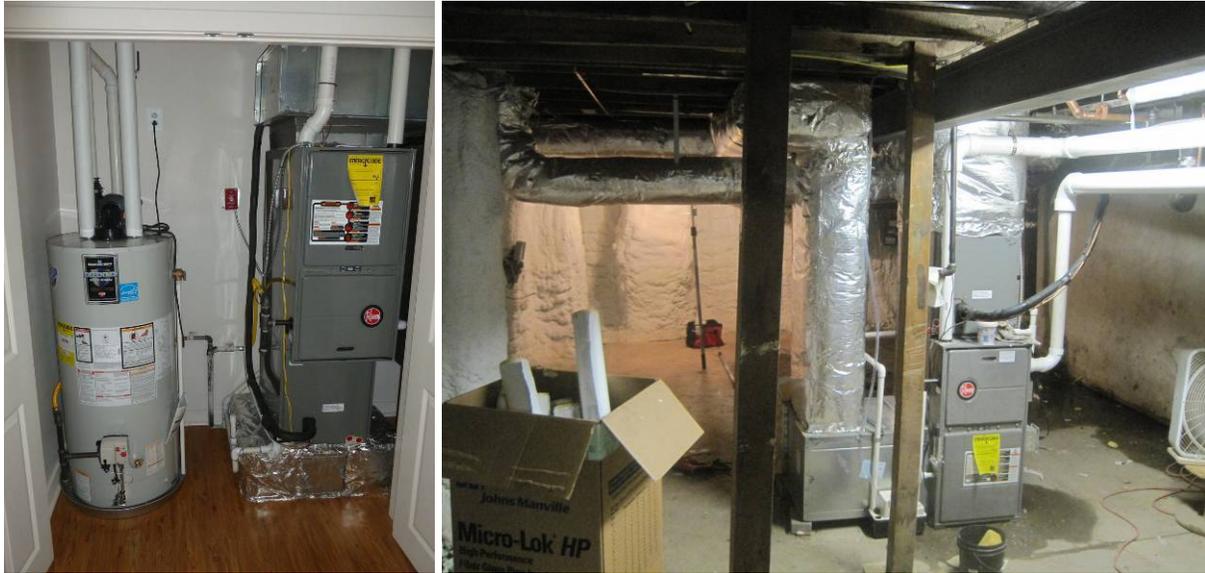
In addition to the performance testing, CARB inspected the overall project and found the installation of the HVAC systems to be a major improvement over the pre-existing systems (Figure 29). The previous concerns of CO spillage into the mechanical closets have been eliminated with the installation of sealed combustion and power/direct vented equipment. However, a CO detector was still installed in these closets as a safety precaution. The HVAC systems for the first floor apartments have been brought within the building envelope and the ducts properly air sealed and insulated.

Figure 29. (L) The furnace and water heater do not draw combustion air from the interior and direct exhaust flue gases to the exterior, so the risk of CO spillage has been drastically reduced. (R) This HVAC system located in a basement has been brought within the thermal envelope of the building and ductwork has been air sealed and insulated.
