56th and Walnut—A Philly Gut Rehab Development

S. Puttagunta, O. Faakye, W. Zoeller
Consortium for Advanced Residential Buildings

July 2013

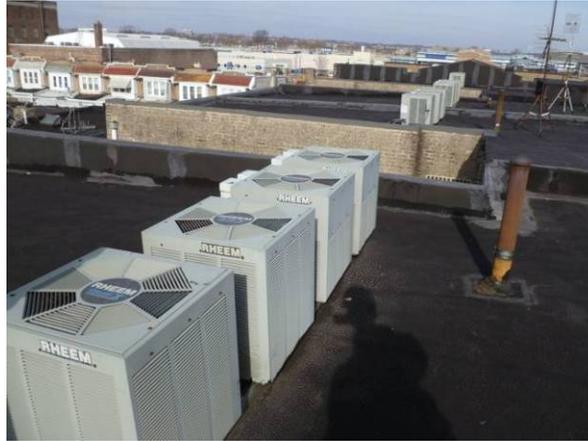
Figure 11. A/C condensing units on rooftop

The furnace units had a heating capacity of 45 kBtu/h with a burner efficiency of 90% AFUE. On the cooling side, 2-ton A/Cs with a SEER 10 rating were supplying each apartment. The cooling equipment was in poor condition. The condenser fins on many of these units were dented or damaged, debris was observed on the indoor evaporator coils resulting in restrictions to heat transfer and airflow, and the A/C units hadn't been serviced in years, so the refrigerant charge was likely low. Actual performance was estimated to be SEER 8 or less. Ductwork runs in the basement for the first-floor apartments (Figure 12), between floors for the second-floor apartments, and in the unvented attic space for the third-floor apartments. The existing sheet metal ductwork was uninsulated, in poor condition, and showed no signs of duct sealing.

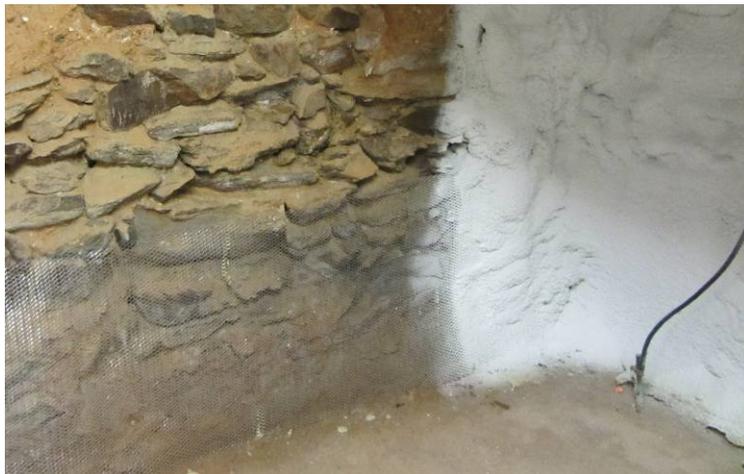
To apply the 3 in. of ccSPF to the rubble stone foundation took a bit of effort. As water and moisture were migrating through the lower portion of the foundation wall, having proper adhesion of the ccSPF directly to the foundation was a challenge. The project team ended up attaching wire mesh to the stone foundation and using that to form a dam of sorts a couple of inches out from the wall and then just filled the space with ccSPF. A spray intumescent coating was applied to the ccSPF insulation to provide a thermal/ignition barrier.

Figure 21. Wire mesh applied to bottom of stone foundation wall to help secure ccSPF in place

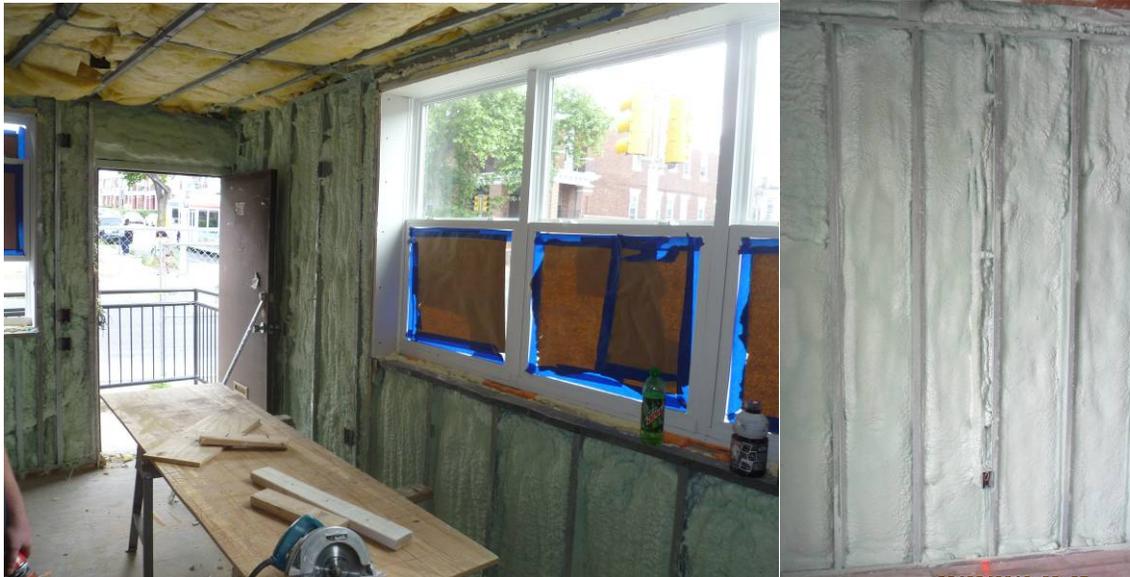
In the pre-retrofit building a wood furring strip was placed between the 2 × 4 steel stud and brick wall; however, CARB suggested that the 2 × 4 steel studs at 16 in. o.c. be set 1 in. from the wall (without the wood furring strip) and the gap filled with continuous ccSPF insulation and extended into the stud cavities for an overall wall assembly of roughly R-22.

Figure 22. Above-grade wall insulation

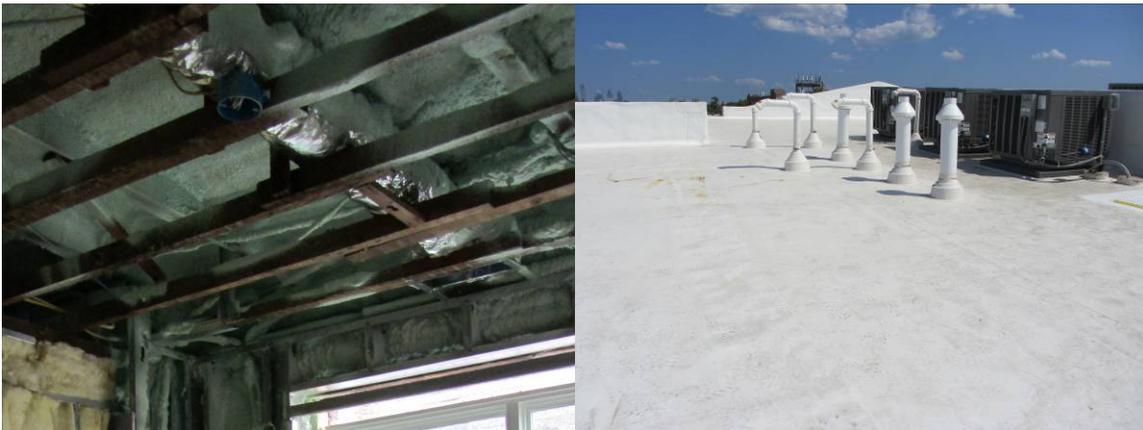
The roof improvements for the third-floor apartments included 3 in. of polyisocyanurate insulation (R-19 continuous) placed above roof deck and 3 in. of ccSPF (R-19) on the underside of the roof deck to create a total roof assembly of R-38. A white TPO membrane was applied over the polyisocyanurate insulation to provide a reflective, “cool-roof” rated weathertight assembly.

Figure 23. (L) 3 in. of ccSPF applied to underside of roof deck; (R) 3 in. of polyisocyanurate applied over the roof deck and covered with a white TPO membrane

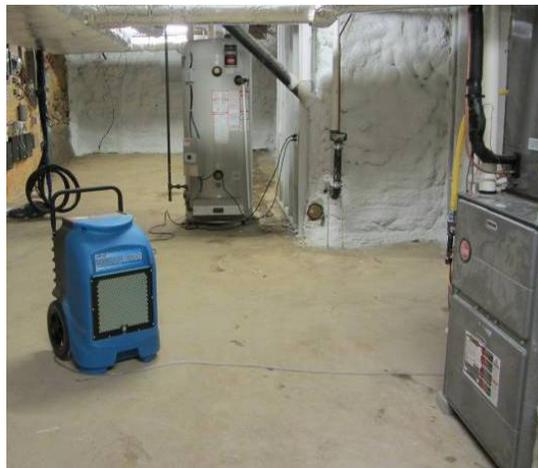
To determine if a dehumidifier would be a sufficient solution to address the high RH levels in these basements, CARB set up temperature and RH sensors in two separate basements in the apartment complex; one with a dehumidifier and the other without a dehumidifier. The dehumidifier had a maximum moisture removal capacity of 145 pints/day.

Figure 30. Stand-alone dehumidifier installed in a basement

The running average RH levels from the basement with a dehumidifier were below 65% and appear to be continually decreasing, unlike the basement without the dehumidifier. Temperatures ranged between 73°–76°F. The data indicate that the dehumidifier is reducing the RH levels in the basement to a safer level. However, as the basement is not directly conditioned, RH levels should continue to be monitored throughout the winter to ensure they do not climb into the range where mold growth is likely. CARB requested that the property manager periodically inspect the basements for moisture and to take temperature and RH measurements. CARB intends to follow up over the coming years to determine the effectiveness of this foundation system.

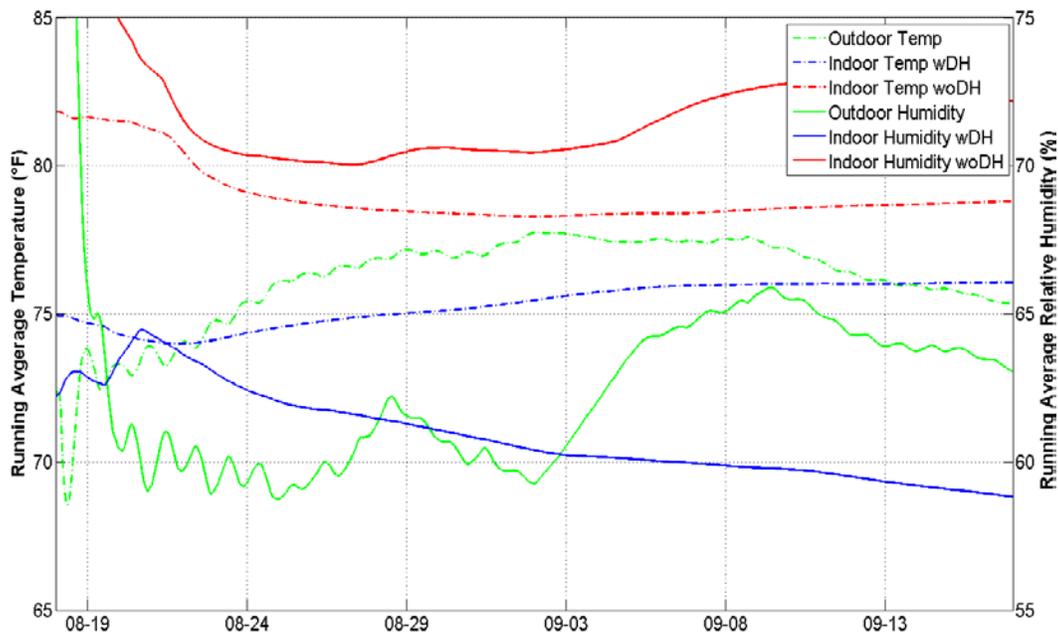
Figure 31 shows a 30-day running average for the temperature and RH data collected at the project site. The dashed lines represent temperature and the solid lines represent RH. The basement measurements are an average of data recorded at three different heights: 1 ft from the basement floor, 4 ft from the floor, and 1 ft from the basement ceiling. The legend descriptions with “wDH” are measurements in the basement with a dehumidifier and “woDH” indicates measurements in the basement without a dehumidifier. It should be noted that these two basements have different ambient air conditions. Therefore, these two cases should not be directly compared to each other, but evaluated individually as the two basements were not baselined.

The running average of the RH readings from the basement without a dehumidifier ranged from 70%–75% and temperatures ranged between 78°–83°F. Although these conditions fall outside the critical thresholds for mold growth according to ASHRAE 160, data were collected for only one month. As temperatures drop outside, basement temperatures may also fall as they are not directly conditioned and duct leakage from the first-floor apartment ductwork has been minimized. If the excess moisture is not removed, RH levels could easily climb into the ideal range for mold and fungi growth.

Figure 31. Temperature and RH 30-day running-average data

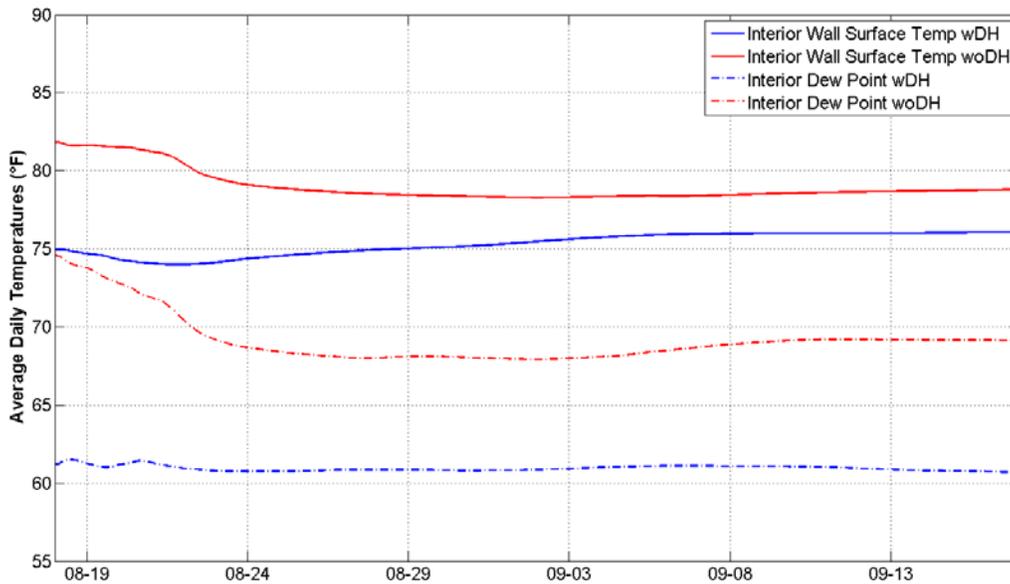
An alternative analysis method, condensation potential, was evaluated for the monitored period for each basement by comparing the interior air dew point temperature to the interior surface temperature of the basement walls. Interior surface temperature was predicted using THERM 6.3, a two-dimensional modeling tool used to evaluate heat-transfer effects in building components. The average daily recorded interior and exterior temperatures were used as the boundary conditions in THERM. As seen in Figure 32, over the monitoring period, there was no potential for condensation forming. The greatest potential for condensation would occur in the winter months, but to date, no signs of condensation in the basements have been observed at the site.

Figure 32. Measured dew point of interior air and modeled surface temperature of foundation wall
